# Lightning Surge Damage in PoE Ethernet Links: A Boyolali Tower Case Study

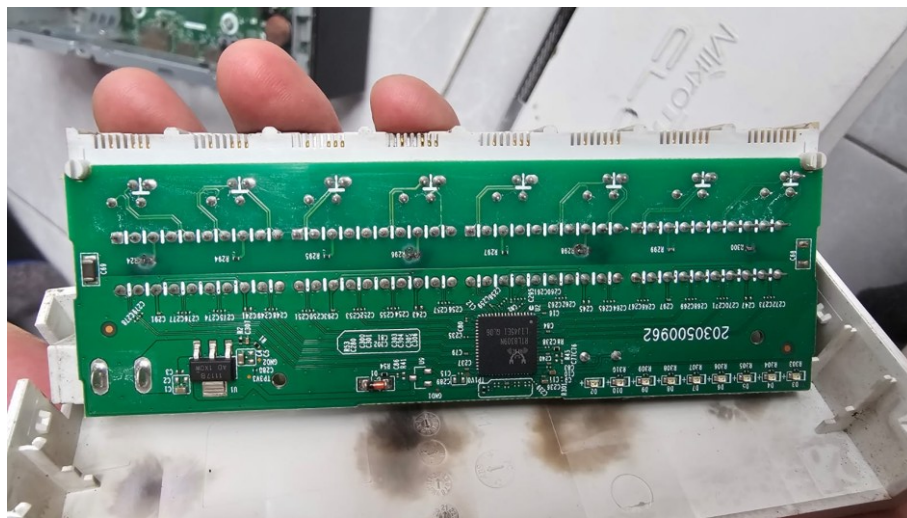
Fig. 4. Internal PCB of a damaged network device, showing localized thermal damage near the input circuitry, indicating surge propagation into the device and subsequent component failure.

The internal damage observed on the PCB confirms that surge energy propagated beyond the external interfaces and affected internal electronic components.

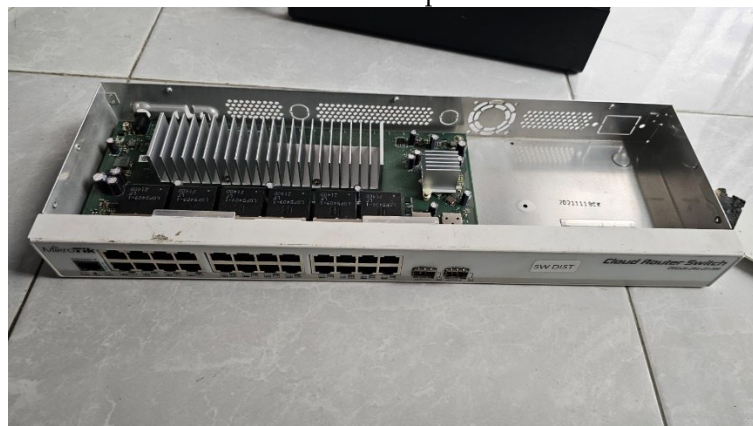
Fig. 5. Internal view of the MikroTik CRS326 switch after the incident. Although no visible burn marks are present, the device failed to operate, indicating internal damage caused by lightning-induced overvoltage.

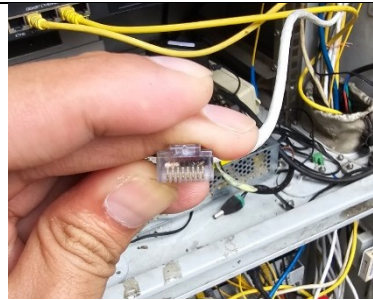
Fig. 6. Damaged RJ45 connector at the tower site, showing burn marks on the contact pins and confirming lightning-induced surge propagation through the Ethernet cable.

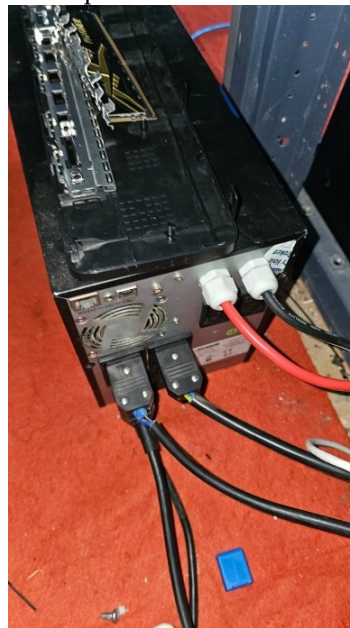
Fig. 7. Uninterruptible Power Supply (UPS) unit used in the system. The unit exhibited no visible physical damage but required a manual restart after the incident.

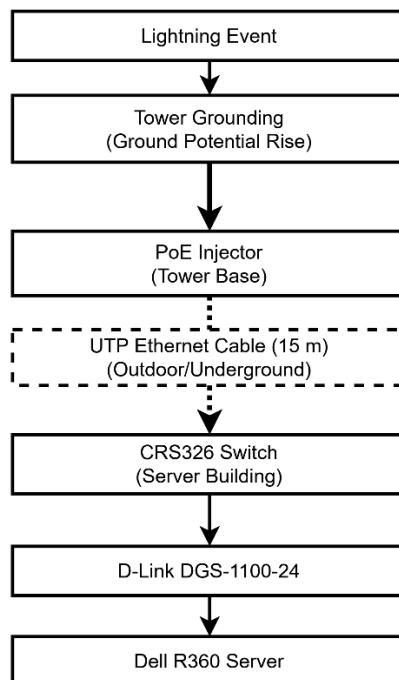
Fig. 8. Simplified illustration of the plausible surge propagation path. The tower grounding system experiences an estimated GPR of approximately 150 kV (for  $I_{peak} = 30kA$ ,  $R_g = 5\Omega$ ). The 15 m UTP Ethernet cable with PoE connects the tower site to the server building, whose grounding system remains at local ground potential.

This mechanism is consistent with the observed damage: PoE-related equipment and both MikroTik CRS326 switches were destroyed, while the server's Ethernet interface survived because the intermediate networking devices absorbed most of the surge energy.

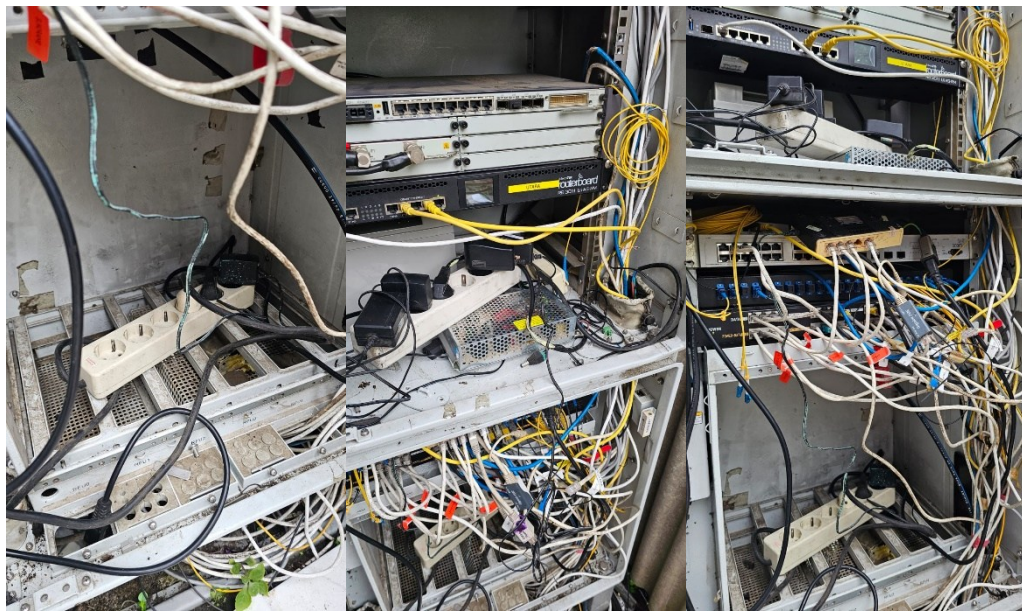
The absence of dedicated surge protection in the tower cabinet, as shown in Fig. 9, further contributed to the susceptibility of the system to incoming transients.

Fig. 9. Power distribution inside the tower cabinet using a standard power strip without dedicated surge protective devices (SPDs). This configuration increases vulnerability to lightning-induced transients.

| Mitigation Strategy | Description | Estimated Cost (USD) | Effectiveness | Reference |
|---|---|---|---|---|
| Surge protective devices (SPDs) | Installation of Type 2 SPDs on PoE lines and Ethernet ports at both ends | 80-200 | High | [8], [17] |
