ANALYSIS OF LANDSLIDES CAUSES ON BTS. KOTA BATU - BTS. KAB. KEDIRI ROAD

¹Bina Marga Public Works, East Java Province
e-mail: d3wi.atikah@gmail.com

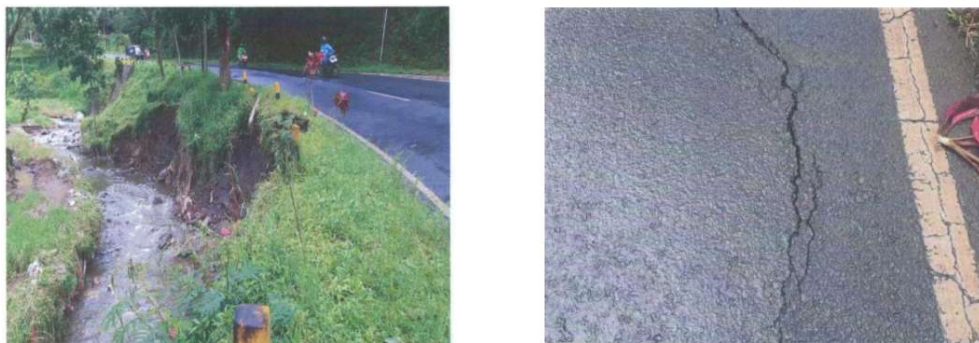
1. It rained on February 19th, 2021 at around 6.00 WIB in Ngroto Village, Pujon District, Malang Regency which resulted in a Natural Disaster on the Bts. Kota Batu - Bts. Kab. Kediri (Link 187) Km. M.Lang 31+350 in the form of a road body that has cracked and subsidence as well as scouring is ± 25 m long, 1.5 m wide and 4.2 m deep.

Figure 2. Photos of Early Avalanches and Early Cracks

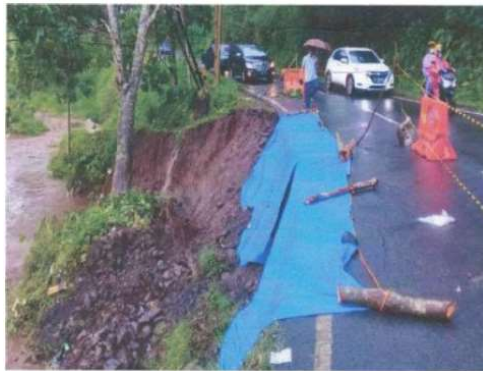
2. On February 28th, 2021, the avalanche has reached the edge of the pavement with a length of ± 25 m, a width of 3 m and a depth of 4.2 m.

Figure 3. Avalanche to the edge of the pavement

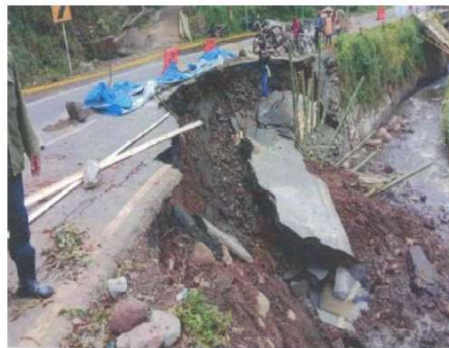
3. On February 4th, 2021 the road damage increased to half of the road body which could potentially damage the entire road so that the road cannot be passed.

Figure 4. Avalanche up to the road body

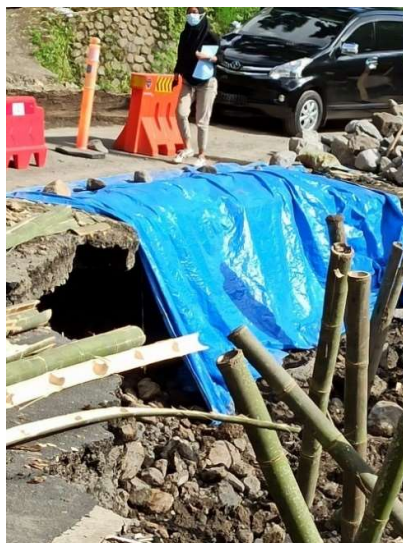
4. On March 6th, 2021, there was another landslide that was getting worse, causing the road body to sink more than half of the road, the scouring was getting wider and the cracks were getting wider, as well as pressure and vibration from vehicles passing above the location.

Figure 5. Avalanche of more than half of the road

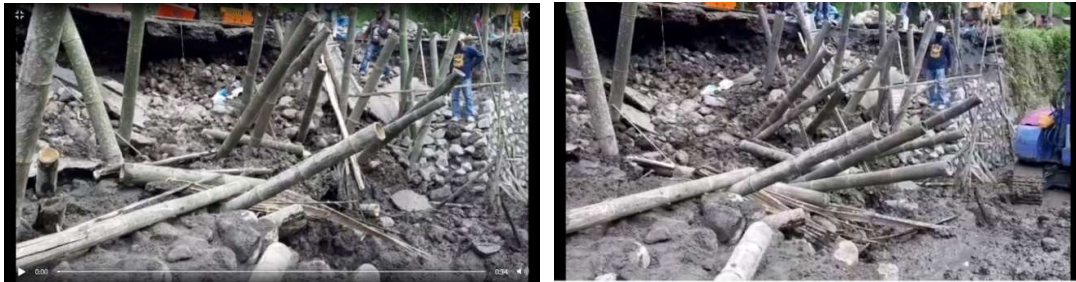
5. Improvements continue to be made by making masonry and niches as shown below. However, it turned out that there was a flow avalanche (liquefaction) in the form of water mixed with sand from the cliff towards the river area from under the road body so that the installed cerucuk collapsed. The liquefaction process caught on camera. The flow of sand mixed with water from the side of the road on the side of the slope pushes the bamboo into the river valley. The flow of watery sand stopped flowing because it was blocked by a large log which was thought to have been buried since ancient times.

Figure 6. Avalanche Flow Process

Based on the chronology above, a hypothesis is obtained about the type of landslide at that location. At the beginning of the failure, the type of soil mass movement, there was a rotational landslide, because it had a curved landslide area. Then in the final phase of the avalanche, a liquefaction flow avalanche occurs, because there is a thick liquid coming out of the inside of the road leading to the valley.

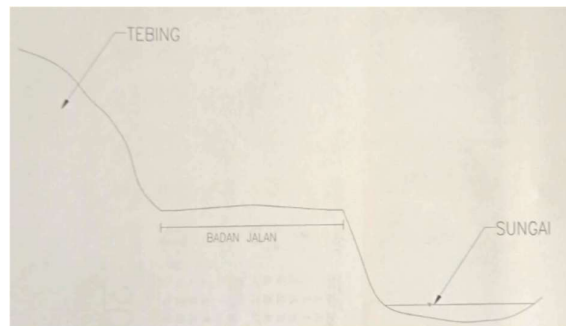
Figure 7. Avalanche Location Sketch

Bts. Kota Batu - Bts. Kab. Kediri. Apart from being adjacent to the slopes on the left side, Kediri is also bordered by the Konto Hulu tributary on the right side, according to the sketch in Figure 7. In addition, there is a spring that continues to flow from the cliff on the left side of the road, which is accommodated by the surrounding community (Figure 8).

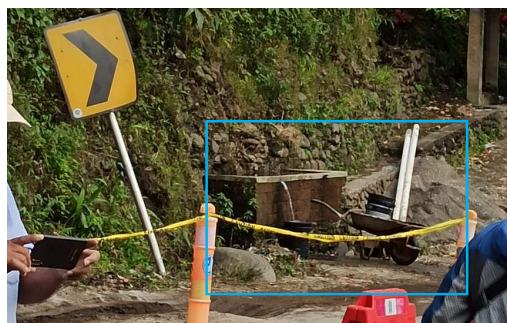
Figure 8. Springs at the Landslide Location

- c. In addition, it is necessary to treat groundwater around the landslide area. Making relief wells can be used as an alternative for sustainable management, considering that around the location there are springs whose water is accommodated by residents. The construction of this relief well is expected to reduce the groundwater level. Furthermore, it is channeled through horizontal drainage which can drain ground water into the canal.
