RIGHT PADDLE REPAIR METHODS FOR IMPROVING TRAFFIC SAFETY AT TRAIN RAILWAY TRACKS

^{1,2} Road and Bridge Engineer, East Java Province Road Agency, Surabaya, Indonesia

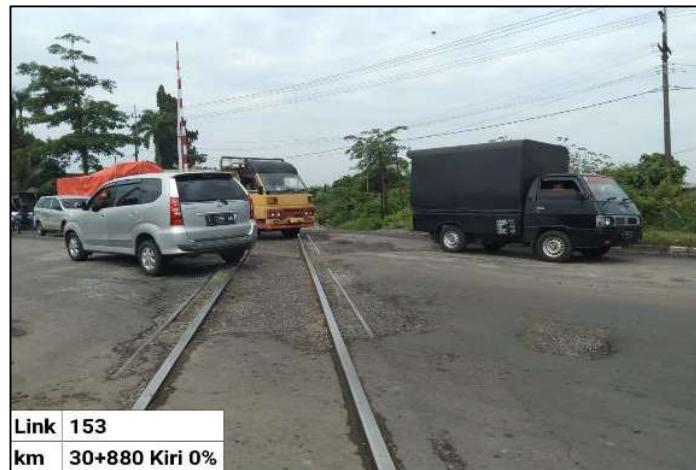
Figure 1. Initial condition of road pavement at JPL 67

Repair of damaged pavement at the crossing of the JPL 67 railroad using CTB [8][9][10] and cold mixed asphalt was performed in March 2022. Repairs were in the form of reconditioning the holes using CTB, then coated with HRS (Hot Rolled Sheet)[11][12]. The method is carried out based on the consideration that the road at the railroad crossing requires high flexibility, with a foundation that is strong enough to withstand vibrations from the dynamic load of the train. The CTB mixture used is directly made at the road repair site.

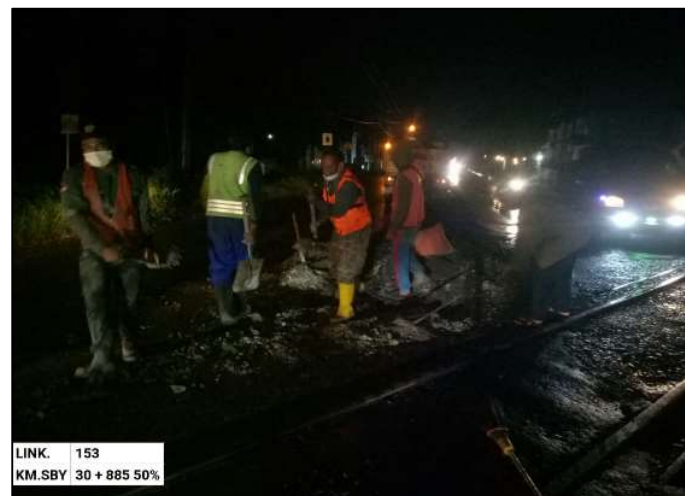
Figure 2. Repair with CTB and HRS at JPL 67

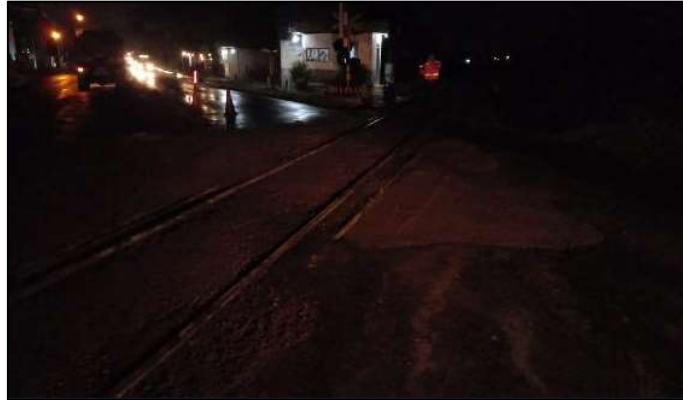
Figure 3. CTB (mixed in site) and Cold Mixed Overlay Results

Due to the demand for speedy handling of road damage and unfavorable weather conditions, the reconditioning for potholes using CTB is not preceded by patching. Repairing damaged roads in the JPL 67 plot of road crossing using this material and method is less efficient because road damage occurs quickly in a not-too-long time (2 months).

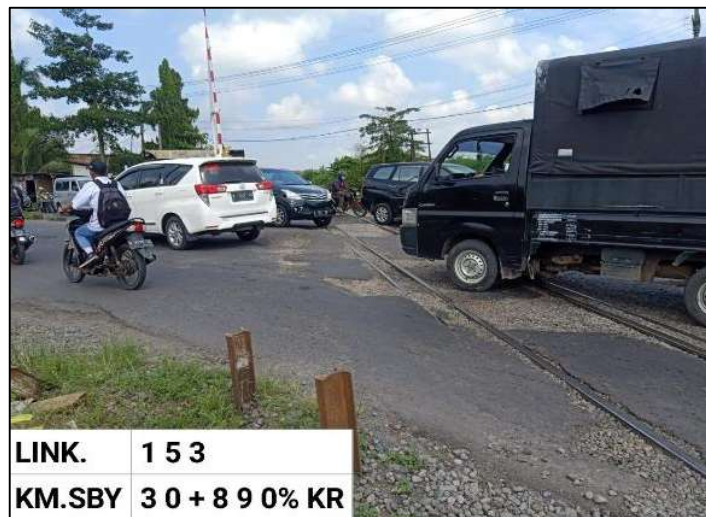
Figure 4. Initial condition of road pavement at JPL 67

In early June 2022, the pavement damage was carried out again at the crossing of the JPL 67 railroad using Cold Mixed Asphalt material. Material selection is based on weather considerations, which still often rain, and the speed of handling road damage is needed.

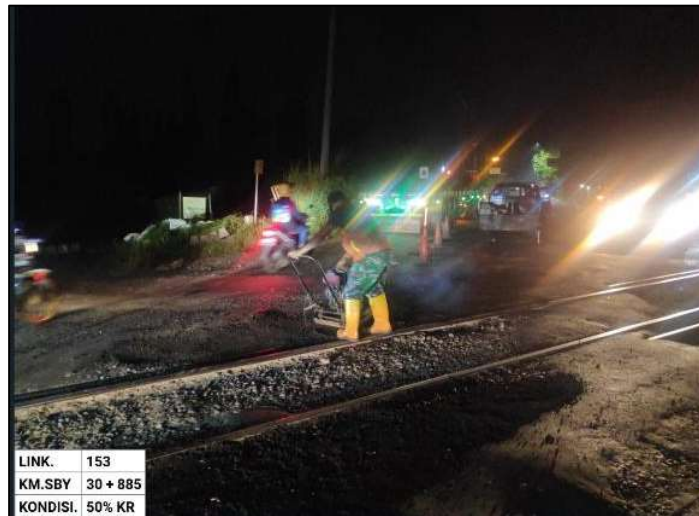
Figure 5. Cold Mixed Overlay at JPL 67

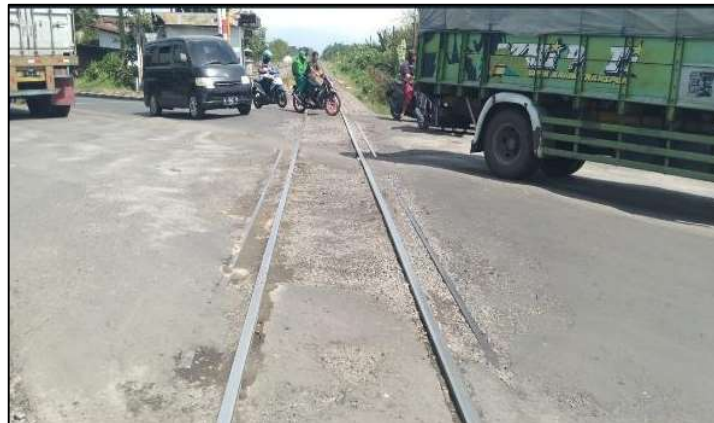
Figure 6. Cold Mixed Asphalt Overlaying Results

Cold-mixed asphalt is used because of the demands on the speed of handling road damage and unfavorable weather conditions. Repairing road damage at the JPL 67 plot of road crossing using cold mixed asphalt is not very effective and efficient because the damage to the pavement occurred again in a relatively short time (2 weeks).

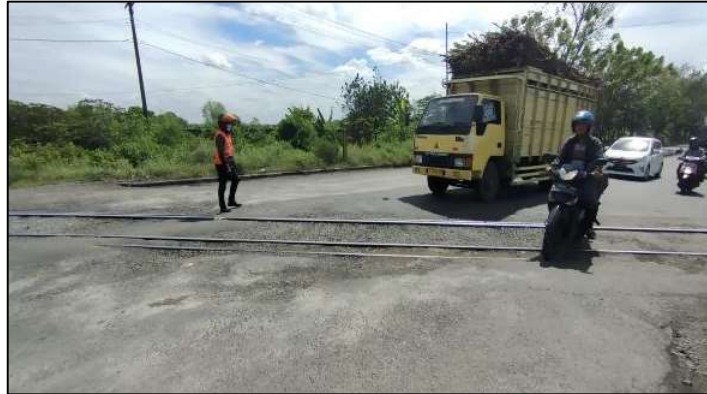
Figure 7. Initial condition of road pavement at JPL 67

In mid-June 2022, repairs were carried out on the damage to the pavement at the crossing of a plot of the JPL 67 railway using CTB and HRS. The method used is the same as the previous road pavement repair: closing the holes using CTB, then coating using HRS. However, there are differences in the manufacture of CTB mixtures, namely, mixing class A aggregates and cement is carried out outside the road handling site, not on site anymore. The proportion of cement used in the CTB mixture was increased, with the aim that the strength of the structure could be higher and stronger to receive vibrations from the dynamic load of the train.

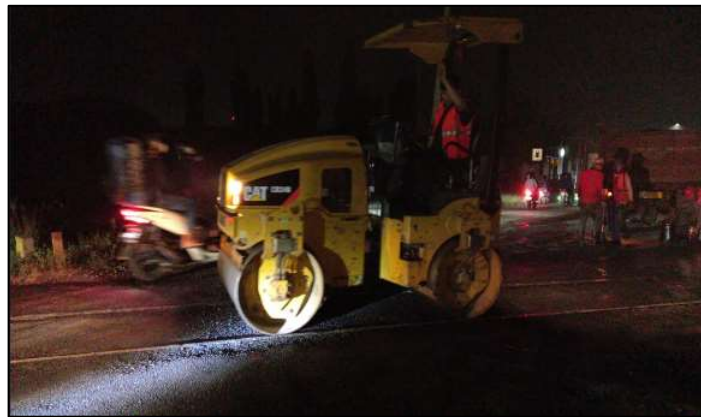
Figure 8. Repair with CTB and HRS at JPL 67

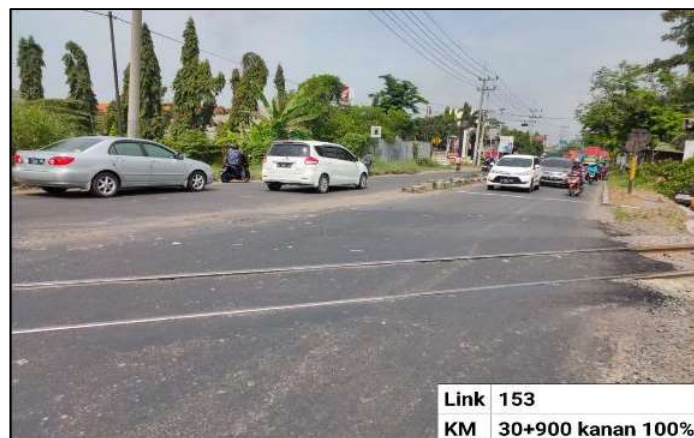
Figure 9. Overlay Results with CTB dan HRS

Before closing the potholes with CTB, patching is done first so that the sides of this intersection are neat. Repairing road damage at the JPL 67 plot of road crossing using CTB mixed outside the site and coated with HRS is more durable. Until the time of this writing, there has been no further damage.
