# Lightning Surge Damage in PoE Ethernet Links: A Boyolali Tower Case Study

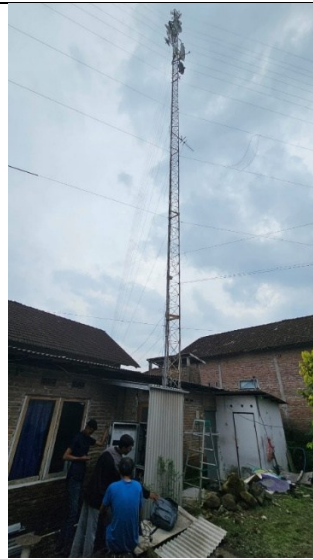
Fig. 1. Communication tower installation at the study site in Boyolali, Central Java, showing the tower structure and associated networking equipment at the base.

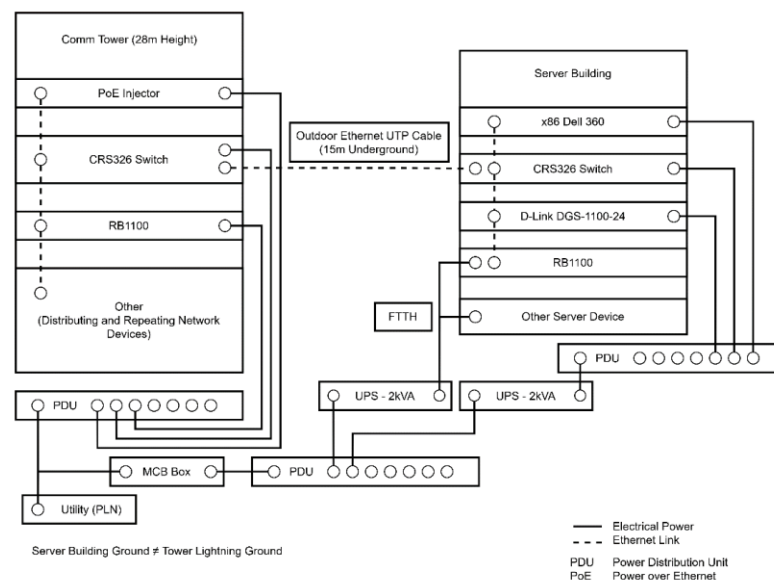
Fig. 2. Schematic diagram of the hybrid electrical and network infrastructure connecting a 28 m communication tower to the server building via a 15 m underground UTP Ethernet link with Power-over-Ethernet (PoE). The tower lightning-protection grounding system is separate from the building electrical grounding system.

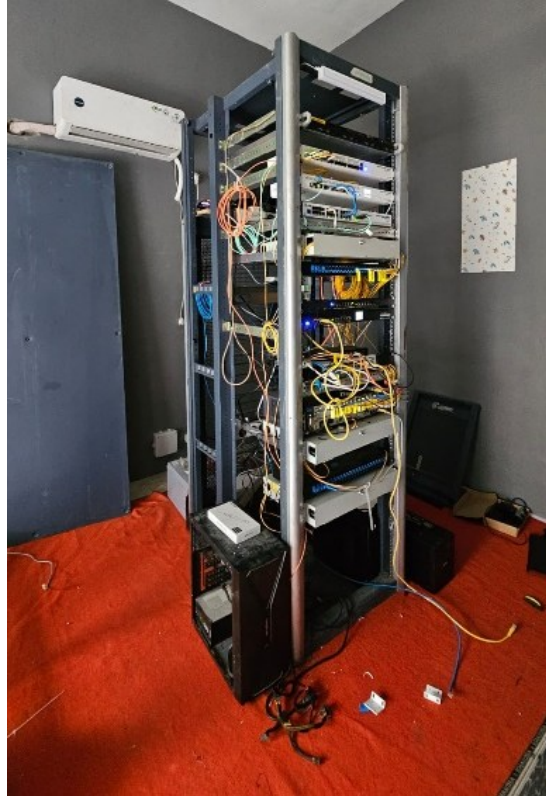
Fig. 3. Server-side rack configuration, showing network switches, servers, and interconnections within the indoor environment.
