ANALYSIS OF LANDSLIDES CAUSES ON BTS. KOTA BATU - BTS. KAB. KEDIRI ROAD

¹Bina Marga Public Works, East Java Province
e-mail: d3wi.atikah@gmail.com

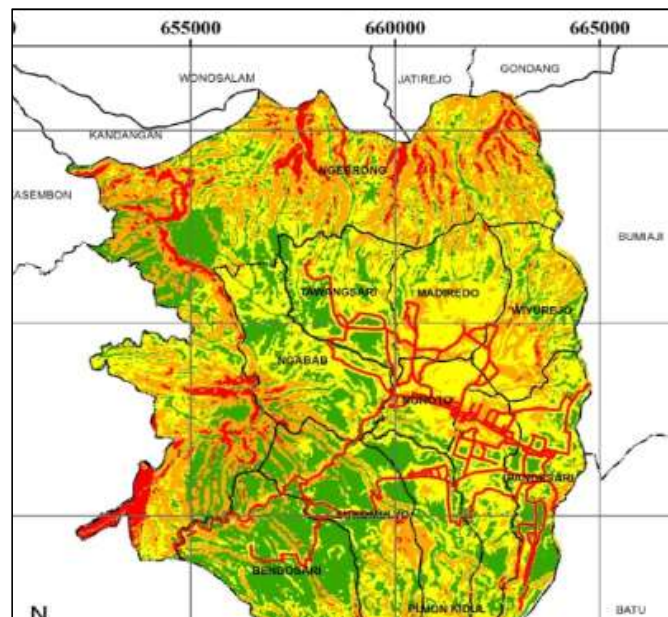
Figure 9. Landslide Hazard Map in Pujon District

Based on the map of estimation of landslide susceptibility in Pujon District, Malang Regency by [5], Ngroto village is an area prone to landslides, as shown in the picture below:

Based on the map above, the Bts. Stone Town - Bts. Regency. Kediri, which is in Pujon District, is in an area prone to landslides. Several years earlier, the road from Batu to Kediri had also experienced a landslide.

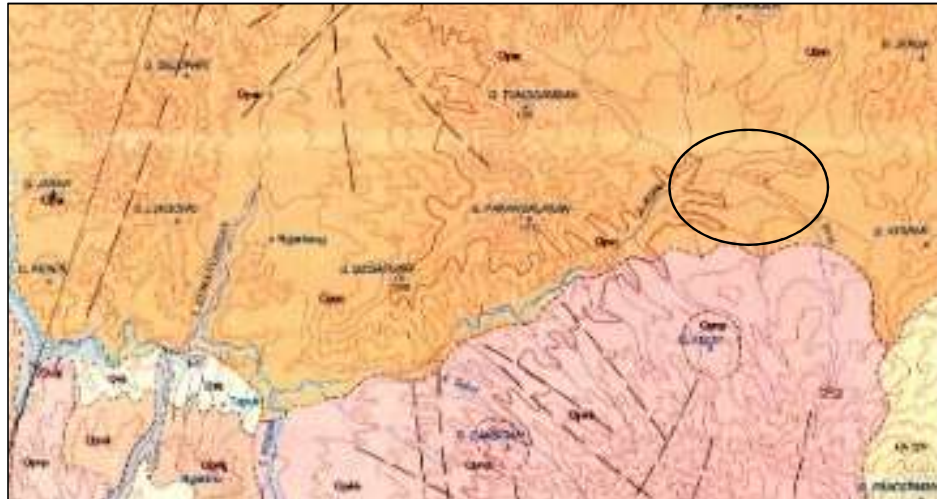
Figure 10. Geological Map

Based on the geological map from [3], the Pujon area with the symbol Qpat (Old Anjasmoro Volcanic Rock) is volcanic breccia, lava, tuff and hacks. This rock is the oldest pyroclastic deposit and is estimated to be of Early to Middle Pleistocene age, which is generally solid and compressed, composed of andesite to basalt, and partially altered. The characteristics of this soil type have a low cohesion value with high permeability. Groundwater can seep easily, thereby

reducing the value of the shear strength of the soil. If there is a discontinuity area in the lower layer, it will be very vulnerable to landslide hazard. More clearly, the geological formation of Ngroto village can be seen in the image below;

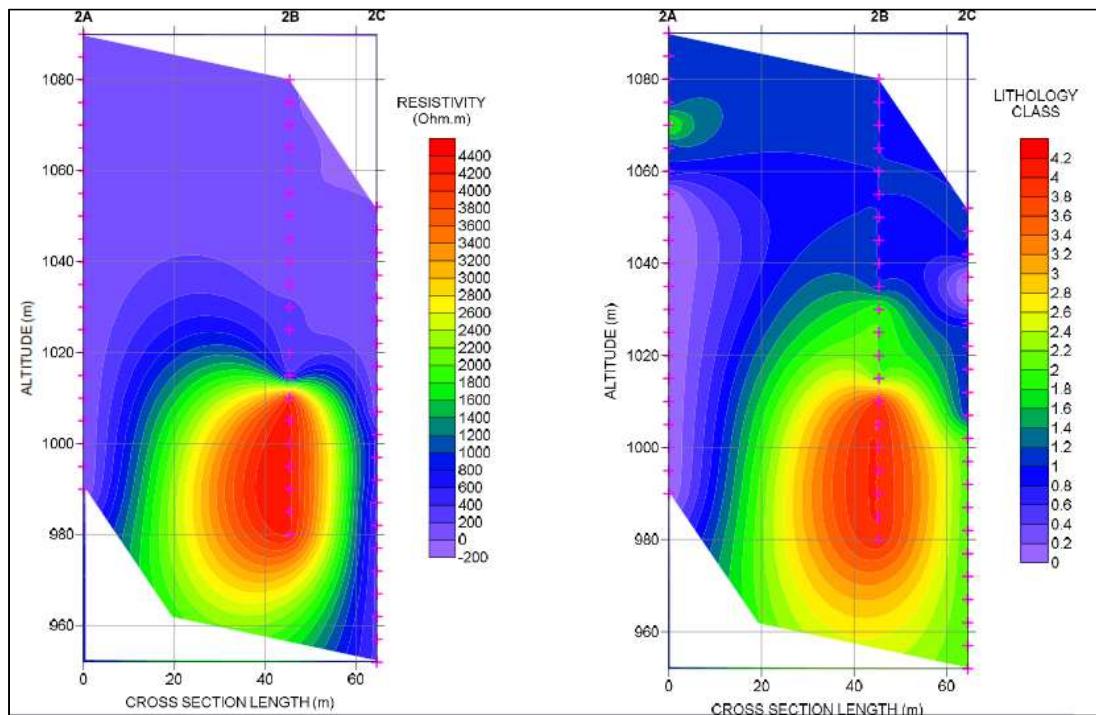
Figure 11. Geoelectricity around the landslide location

- e. The location of the landslide road body is at coordinates 7050' 43.1 S and 1120 26'44.1 E. Based on the results of the analysis by [7], the coordinates around the location have stability between 0.30 – 0.31. The following is the result of geoelectricity around the landslide location:

- f. Soil materials. The soil material at this location is sandy soil. has high permeability. Groundwater can seep easily, thereby reducing the value of the shear strength of the soil.
