Analysis of Wifi Signal Distribution and Access Point Placement Using Site Survey and Heatmap Visualization: A Case Study of A Government Office Building

Nadila Yuliati Matulessy[1], Edi Prihartono[1]
[1]Departement of Informatic Engineering, Universitas Dr. Soetomo, Surabaya, Indonesia
*email:dilayuliati165@gmail.com**

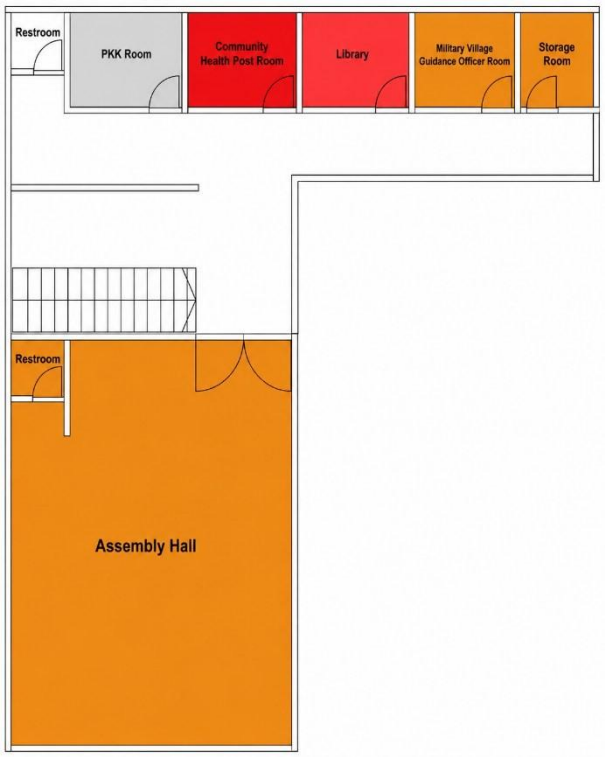
Fig. 4. Visualization of AP 1 (Initial) Heatmap on Floor 2

Based on Figure 4, the distribution of the WiFi signal from AP-1 (initial) on the 2nd floor is dominated by moderate to weak categories, with moderate signal quality in the Hall and weak signal quality in several rooms such as the Library Room and the Health Center Room. This condition indicates that the placement of the AP on the 1st floor is not yet able to provide optimal signal coverage to the 2nd floor due to the vertical distance and physical barriers of the building, resulting in areas with low signal quality.

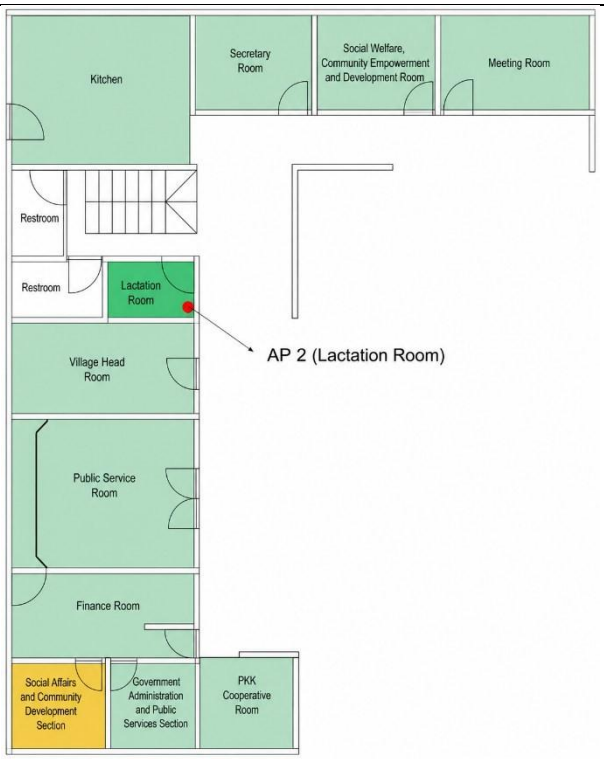
Fig. 5. Visualization of the Second AP Heatmap (Lactation Room) on the 1st Floor

Based on the heat map shown in Figure 5, the area around the Lactation Room, where the second AP is located, is dominated by green. This condition indicates that the room and its surrounding area receive relatively good WiFi signal strength, resulting in strong and stable network connectivity. This is in line with the position of the AP in the Lactation Room, allowing the signal to propagate optimally to the surrounding area.

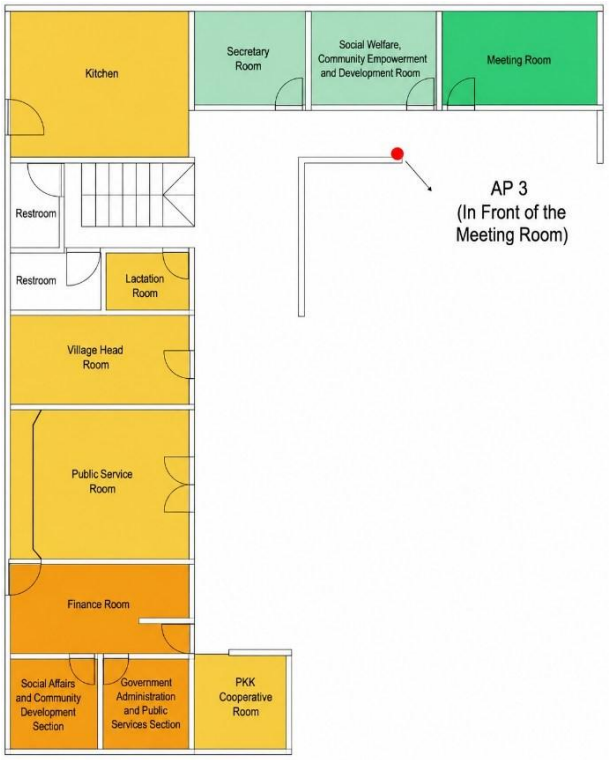
Fig. 6. Visualization of the 3rd AP Heatmap (Front of Meeting Room) on the 1st Floor

Based on the heatmap shown in Figure 6, the area around the Meeting Room and the Peace, Order, and Development Section Room is dominated by green. This condition indicates that the WiFi signal strength in the area adjacent to the position of AP 3 is in the strong and relatively stable category, thus able to support optimal network activity. Meanwhile, several other rooms such as the Secretary's Room, the Village Head's Room, the Service Room, and the Lactation Room are shown in yellow, which indicates that the WiFi signal in these areas is in the moderate category due to the increasing distance from the AP.

At the bottom of the floor plan, specifically the Government and Public Service Section Room and the People's Welfare and Economy Section Room, orange is used to indicate weak WiFi signal quality. This condition is influenced by the considerable distance from the 3rd AP location and the presence of physical barriers in the form of walls and building partitions that obstruct signal propagation. In general, the heatmap of AP 3 on the 1st floor shows that the WiFi signal distribution is not yet completely even, with the best signal quality in the area around the Meeting Room and decreasing in areas further away from the AP.

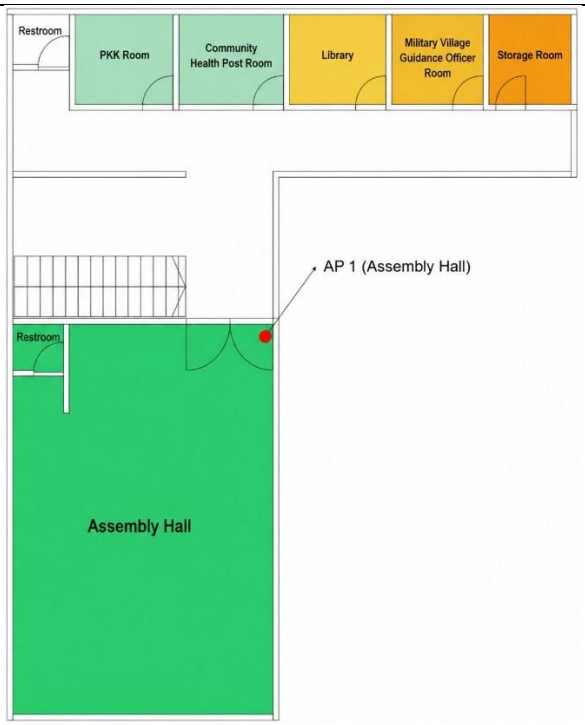
Fig. 7. Visualization of Heatmap AP 1 (Hall Room) on the 2nd Floor

Based on the heatmap shown in Figure 7, the Hall area, which is the location of AP 1 on the 2nd floor, is dominated by green. This condition indicates that the WiFi signal strength in the Hall area is strong and relatively stable, because the AP is located directly inside the room so that signal propagation can optimally reach the surrounding area. Apart from the Hall, several adjacent rooms such as the PKK Room and the PosKesKel Room are displayed in light green, which indicates that the WiFi signal is still in the fairly good category despite experiencing a slight decline due to distance and structural barriers.

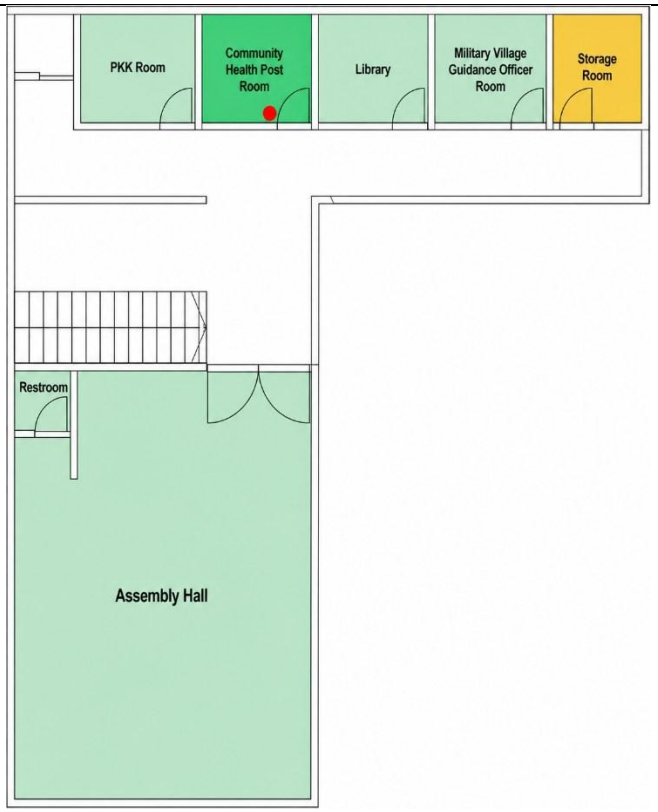
Fig. 8. Visualization of the 2nd AP Heatmap (PosKesKel Room) on the 2nd Floor

Meanwhile, the Warehouse Room has the lowest SNR value of 22.25 dB, which indicates lower signal quality due to the greater distance from the AP and the presence of physical barriers in the form of walls and building partitions. In general, the SNR calculation results show that the quality of the WiFi signal from AP 2 on the 2nd floor tends to decrease with increasing distance from the AP location and the environmental conditions of the room.
