EVALUATION OF THE LEVEL OF ROAD DAMAGE IN JELIDRO II-KUWUKAN-SAMBIKEREP ROADS USING THE PAVEMENT CONDITION INDEX (PCI) AND BINA MARGA METHOD

Thasyara Nurhijriyah¹, Kurnia Hadi Putra², Theresia Maria Chandra Agusdini³

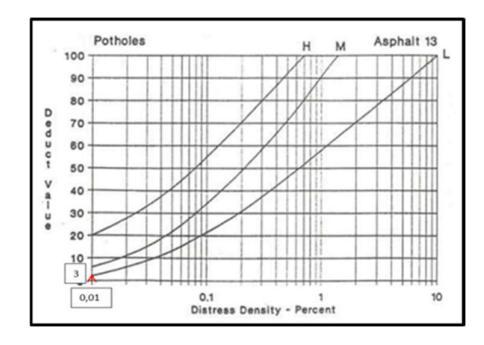
Figure 2. Correlation Curve of density and level of damage on Potholes (L)

Deduct value is determined by correlation curve from density with level of damage differentiated for each type of damage.

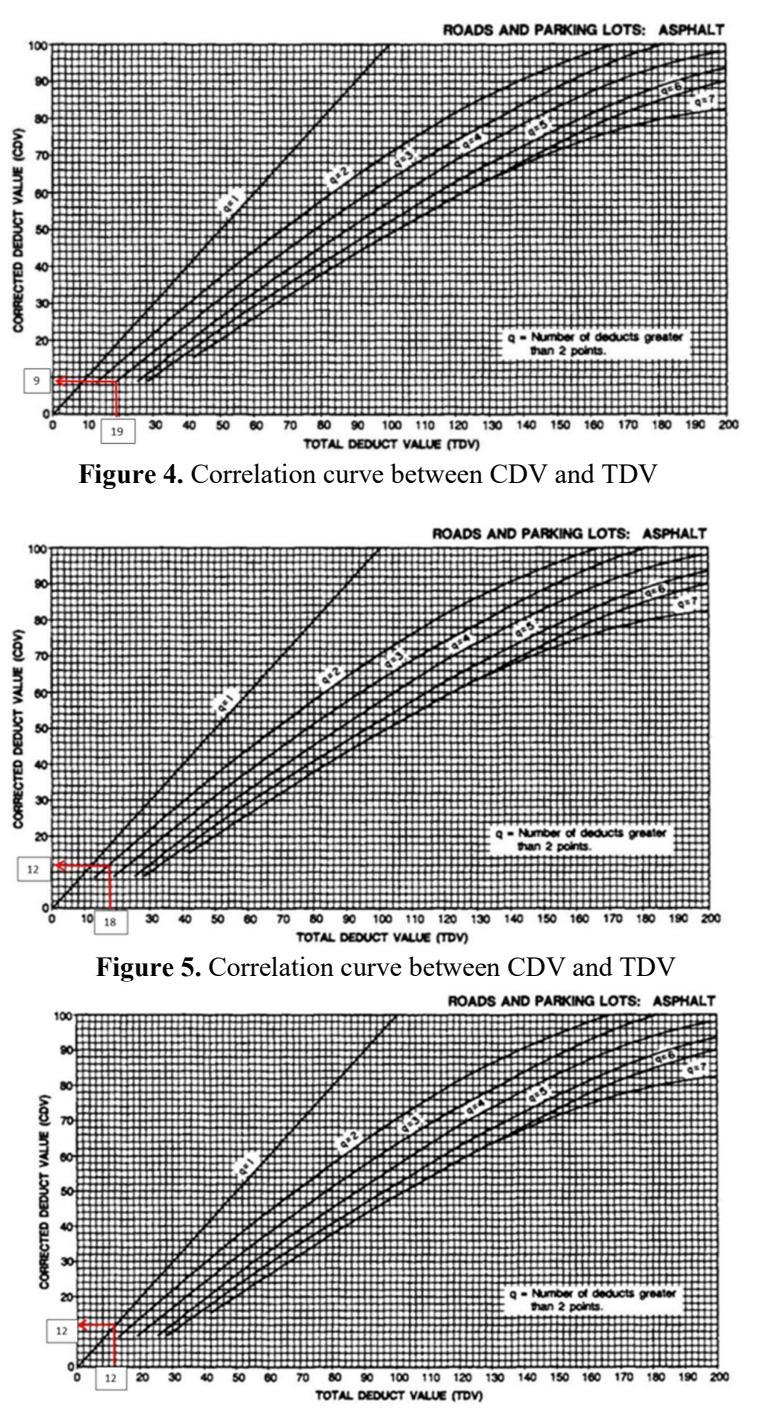
Figure 6. Correlation curve between CDV and TDV

The way to determine the CDV is by the curve of correlation between TDV and q. The TDV value is drawn vertically until it intersects with the line of q, after which it is drawn horizontally to the left in the direction of the CDV value. It can be seen in images 4, 5, and 6 that the CDV values at STA 0+000 until 0+100 are 9, 12, and 12.
